CONNECTICUT RIVER BASIN  
SHUTESBURY, MASSACHUSETTS

LAKE WYOLA  
MA 00510

PHASE I INSPECTION REPORT  
NATIONAL DAM INSPECTION PROGRAM

MARCH 1979

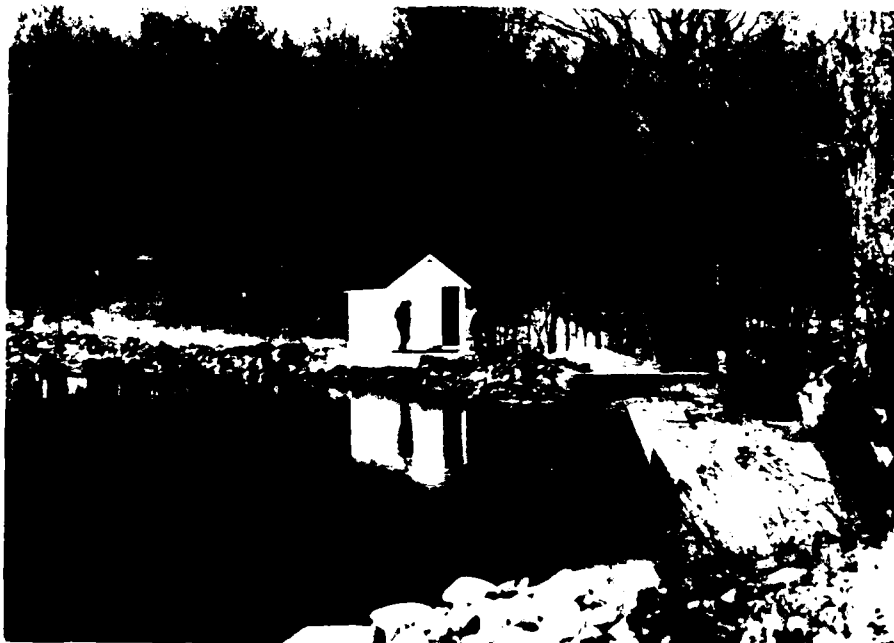
PHOTO NO. 1 - Upstream portion of dam as viewed from right abutment area.

- (1) Vegetation on the upstream slope should be removed. All trees within 20<sup>+</sup> feet of the downstream face should be removed. These trees are shown by Photos 1,3,4,5,7,8, & 13 and their approximate locations are indicated on the Plan view in Appendix B of this report.
- (2) The wet areas noted in this inspection report should be observed during routine maintenance to determine evidences of soil transport.
- (3) Riprap should be placed on the discharge channel opposite the spillway apron and on the channel floor for a downstream distance of 20 feet.
- (4) This dam should be inspected every two years by qualified personnel who can identify areas of concern which, if left unchecked could jeopardize the safety of the dam.
- (5) A formal warning system should be developed for warning downstream residents in case of emergency.

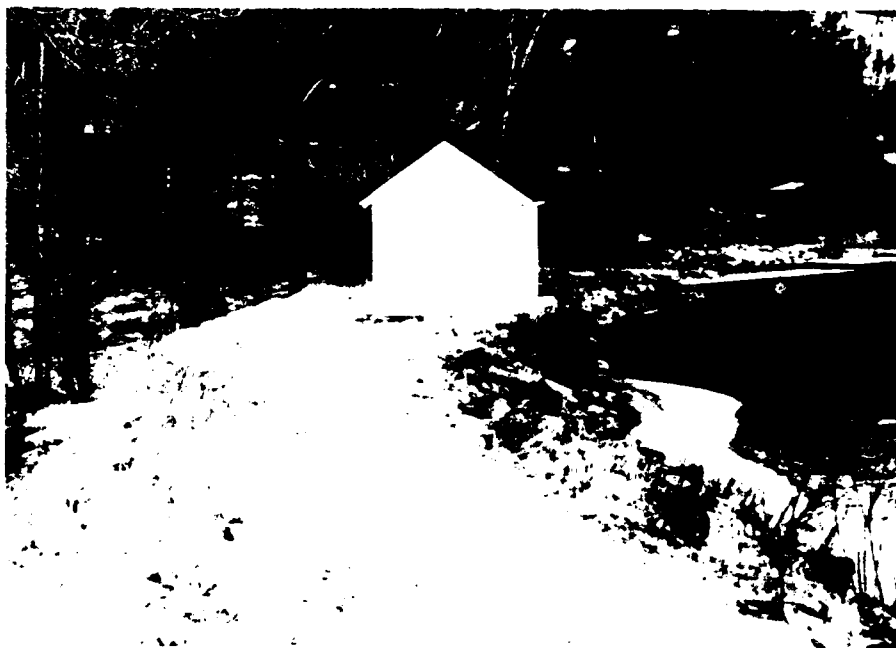
PHOTO NO. 7 - Crest of dam as viewed from left abutment  
area.

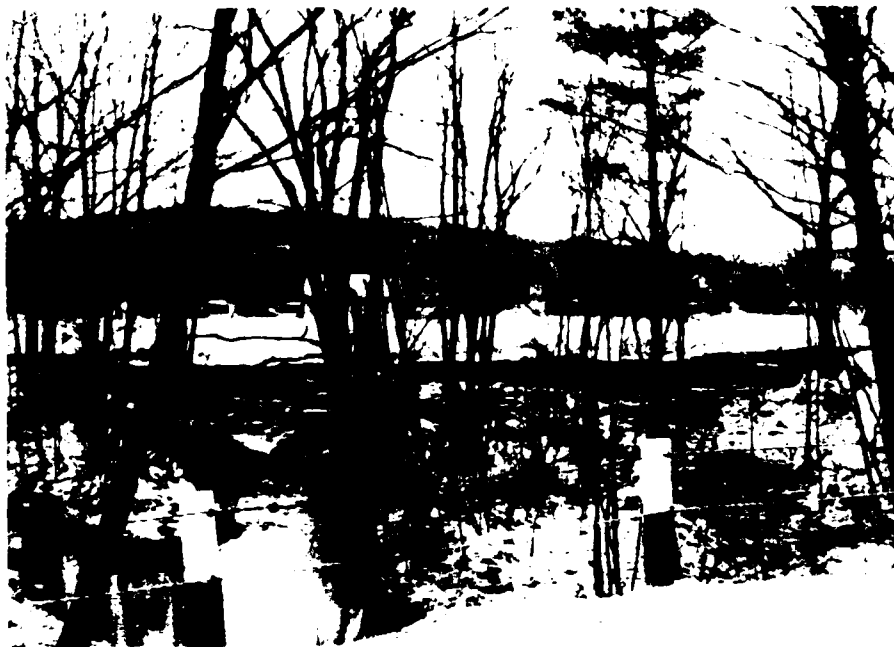
PHOTO NO. 12 - Overall view of downstream face of dam.
